CHARACTERISTIC OF THE VERTICAL SEISMIC WAVES
ASSOCIATED WITH THE 1995 HYOGO-KEN NANBU (KOBE), JAPAN
EARTHQUAKE ESTIMATED FROM THE FAILURE OF
THE DAIKAI UNDERGROUND STATION

Earthquake Engineering and Structural Dynamics, Vol.29(6), pp.813-821, 2000.

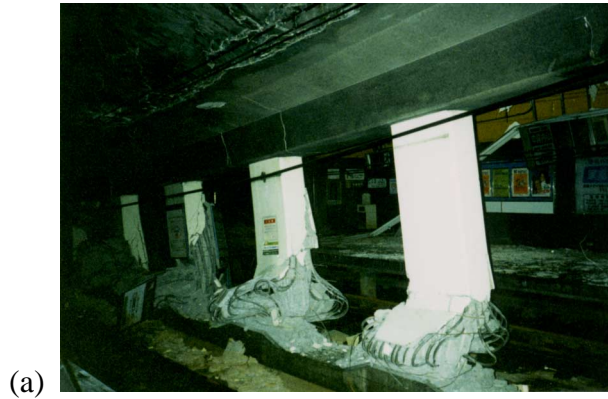
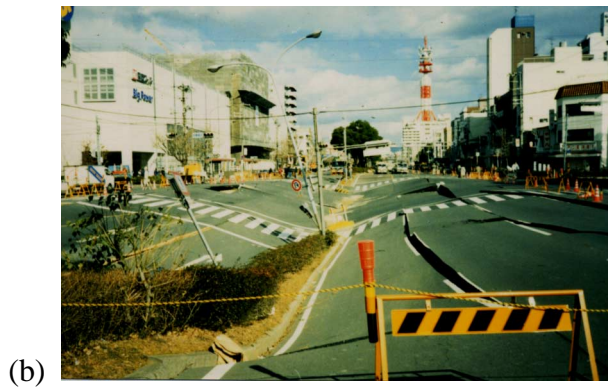
Figure 2. Dynamic failure of the Daikai Underground Station, Kobe. (a) Failure of columns supporting the roof at midspan (central columns) resulted in the collapse of the roof [Near the cross-section ④-④ in Figure 1(e)]; and (b) substantial settlement of the roadway caused by the collapse of the Daikai Station underneath.

As the possible reasons of the collapse of the columns at the Daikai Station, several models have been proposed: failure in shear and/or bending due to the horizontal vibrations; and buckling due to the vertical impact¹⁻¹¹. However, it is difficult to explain the damage generation using the shear/bending model: Large shearing deformation of structures such as observed on the surface is not expected in the underground where the structural movement is restricted by the surrounding media². Moreover, the columns at the Daikai Station were designed not to induce bending moments at their ends, and in Kobe, considerable vertical oscillations were experienced and failures of structures that can be explained more easily with a vertical oscillation model have been reported^{8,9}. Therefore, the failure was possibly induced by vertical oscillations^{2,8,9}.

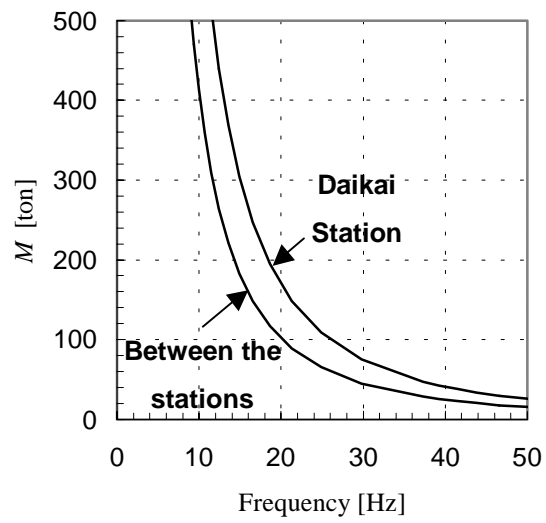
Figure 5. The relation between the resonant frequency of the incident wave and the overburden M in and near the Daikai Station.

Referring to the real dimensions of the Daikai Station, the relation between the resonant frequency of the incident wave and the load M acting on the column is calculated. The results are shown in Figure 5. In the calculations, the following material properties are used.

From Figure 5, the dominant frequency of the seismic waves that impinged upon the Daikai Station can be estimated: Assuming that the density of the surrounding medium is 1800kg/m^3 , the interval of the columns is either 3.5m (at the Daikai Station) or 2.5m (between the stations) and regarding the tunnel as a frame structure, one can calculate the load M acting on the column at each section of the box structure (sections ①-① to ⑤-⑤ in Figure 1). The load at each section in Figure 1 is listed in Table 1. Figure 5, together with Table 1, indicates that in the case the dominant frequency of the incident wave is about 17Hz, the overburden M that induces resonance is some 235ton (at the Daikai Station) or 140ton (between the stations) and only the columns at the sections ②-②, ③-③ and ④-④ [Figure 1(c)-(e)] resonate (or vibrate strongly) and can fail. In this case the columns at the sections ①-① and ⑤-⑤ [Figure 1(b), (f)] do not resonate. As the epicenter of the Hyogo-ken Nanbu Earthquake is located very close to the Daikai Station, it is possible that these high frequency seismic waves interacted with the station before attenuation. This example shows that underground structures can detect waves of a specific frequency, and the wave-induced damage to underground structures can concentrate on the sections with specific overburden.
